Instrument Flying Handbook (FAA-H-8083-15B) Addendum:
Angle of Attack Indicators
April 2015

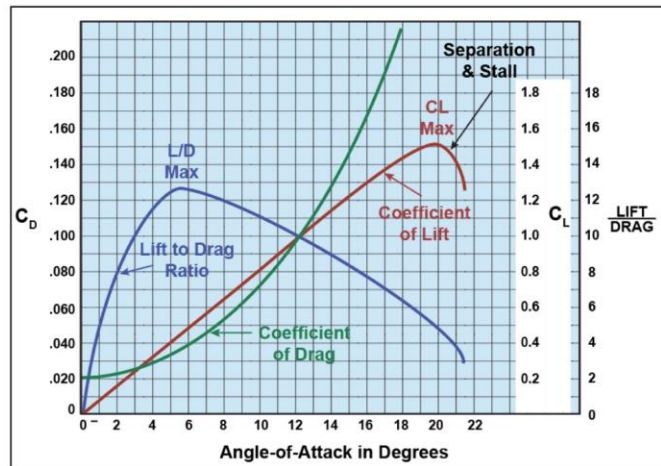
Figure 2. Lift/drag curve.

An AOA indicator can have several benefits when installed in GA aircraft, not the least of which is increased situational awareness. Without an AOA indicator, the AOA is “invisible” to pilots. These devices measure several parameters simultaneously and determine the current angle of attack providing a visual image to the pilot of the current AOA along with representation of the proximity to the critical AOA. These devices can give a visual representation of the energy management state of the airplane. The energy state of an airplane is the balance between airspeed, altitude, drag, and thrust and represents how efficiently the airfoil is operating. With this increased situational awareness pertaining to the energy condition of the airplane, the pilot will have information that they need to aid in preventing an LOC scenario resulting from a stall/spin. Additionally, the less energy that is utilized to maintain flight means greater overall efficiency of the airplane which is typically realized in fuel savings. This equates to a lower operating cost to the pilot.
